Engine Bearing

failure analysis guide

*A guide to analysis and correction of
premature engine bearing failures*

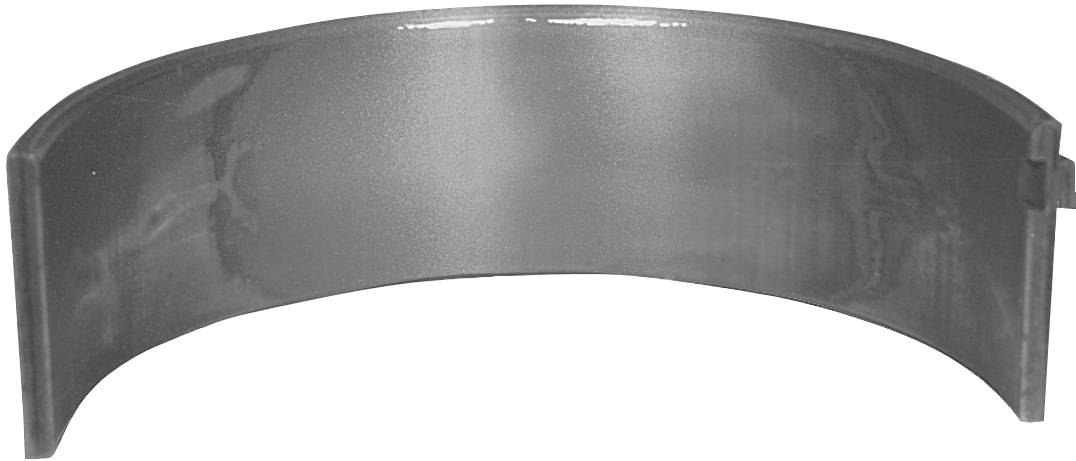
Uniform wear pattern over approximately 2/3 of the bearing's surface. Wear should diminish near the parting line ends of the bearing, and the wear pattern should extend uniformly across the bearing in the axial direction.

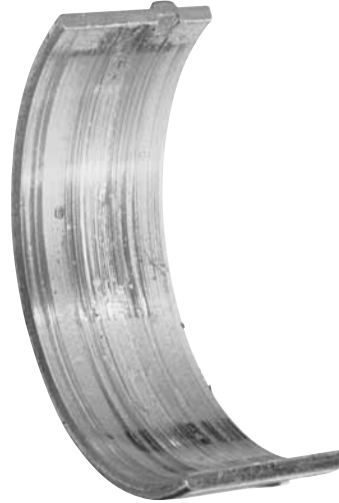
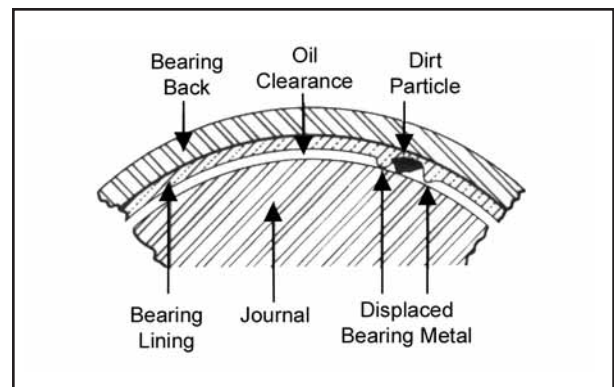
Foreign particles are embedded in the lining of the bearing. Scratch marks may also be visible on the bearing surface.

The high-spot may be large enough to make contact with the journal causing a rubbing action that can lead to the eventual breakdown and rupture of the bearing lining. Foreign particles may embed only partially and the protruding portion may come in contact with the journal and cause a grinding wheel action.

1. Install new bearings, being careful to follow proper cleaning procedures.
2. Grind journal surfaces if necessary.
3. Recommend that the operator have the oil, air filter, oil filter and crankcase breather-filter replaced as recommended by the manufacturer.

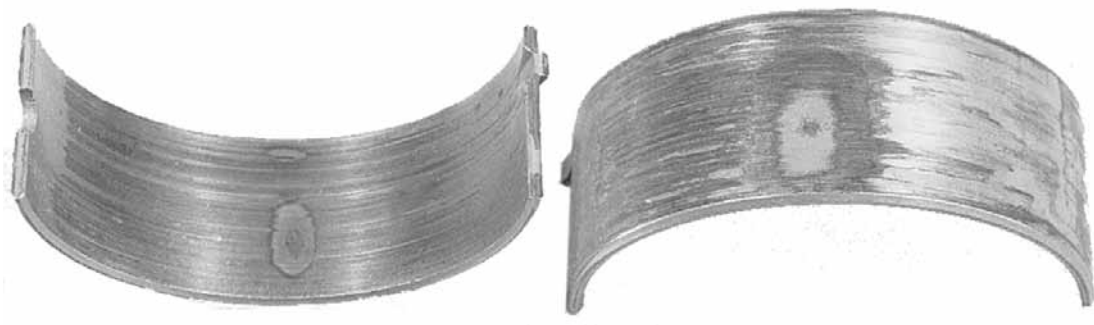
A localized area of wear can be seen on the bearing surface. Also, evidence of foreign particle(s) may be visible on the bearing back or bearing housing directly behind the area of surface wear.

Also, an uneven distribution of the load causes an abnormally high pressure area on the bearing surface, increasing localized wear on this material.

1. Install new bearings following proper cleaning and burr removal procedures for all surfaces.
2. Check journal surfaces and if excessive wear is discovered, regrind.

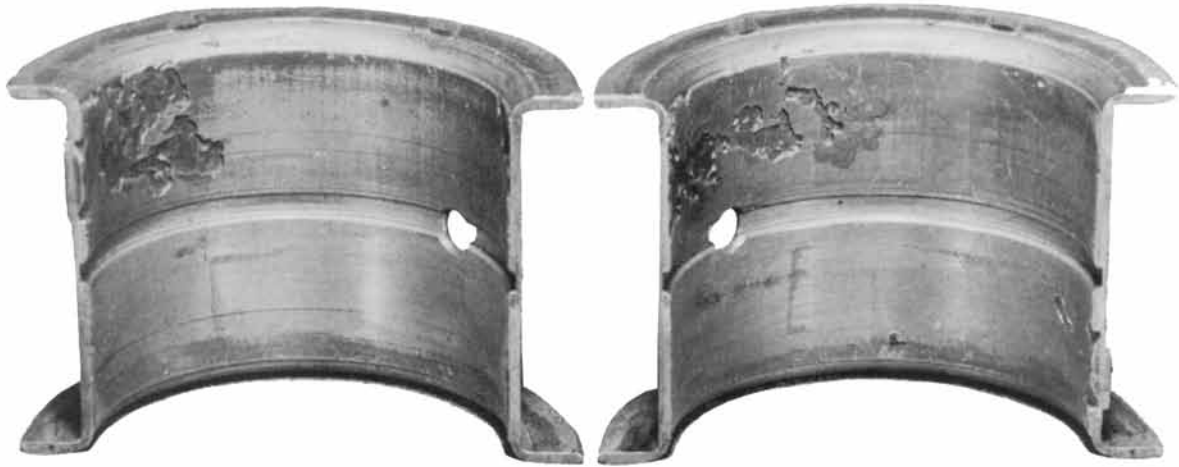
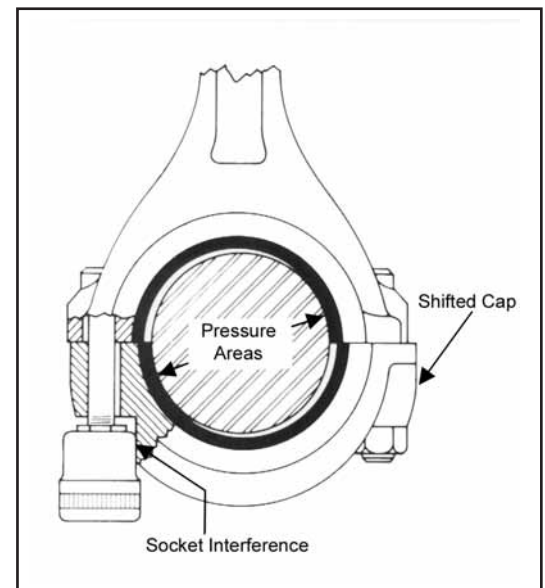
Excessive wear areas can be seen near the parting lines on opposite sides of the upper and lower bearing shells.

The resulting metal-to-metal contact and excessive pressure cause deterioration of the bearing surface and above normal wear areas.

1. Using too large a socket to tighten the bearing cap. In this case, the socket crowds against the cap causing it to shift.
2. Reversing the position of the bearing cap.
3. Inadequate dowel pins between bearing cap and housing (if used), allowing the cap to break away and shift.
4. Improper torquing of cap bolts resulting in a "loose" cap that can shift positions during engine operation.
5. Enlarged cap bolt holes or stretched cap bolts, permitting greater than normal play in the bolt holes.

1. Check journal surfaces for excessive wear and regrind if necessary.
2. Install the new bearing being careful to use the correct size socket to tighten the cap and the correct size dowel pins (if required).
3. Alternate torquing from side to side as to assure proper seating of the cap.
4. Check the bearing cap and make sure it's in its proper position.
5. Use new bolts to assure against overplay within the bolt holes.

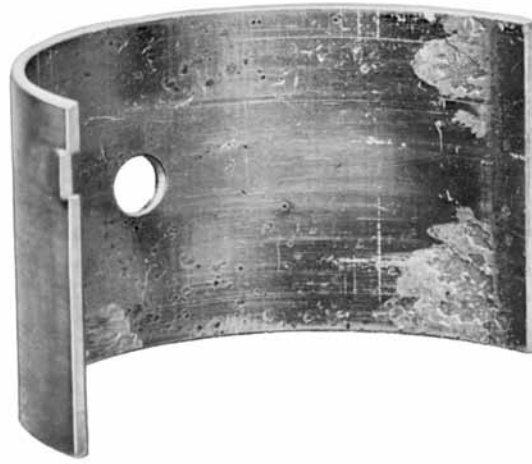
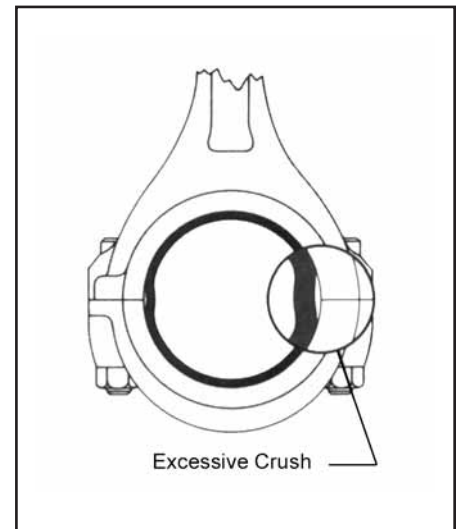
Extreme wear areas visible along the bearing surface adjacent to one or both of the parting line.

When there is too much crush, however, the additional compressive force created by the surplus crush that still remains after the bearing is fully seated causes the bearing to bulge inward at the parting faces. This bearing distortion is called “side pinch.”

1. Rework the bearing housing of the engine block if it has been filed down.
2. Replace the connecting rod if its bearing cap has been filed down.
3. Check journal surfaces and regrind if necessary.
4. Install the new bearing and follow proper installation procedures by never filing down bearing caps and using the recommended torque wrench setting.
5. Correct the shim thickness (if applicable).
6. Check for out-of-roundness of the inside diameter of the assembled bearing by means of an out-of-roundness gauge, inside micrometer, calipers or prussian blue to assure that any out-of-roundness is within safe limits. The maximum assembled bearing I.D. should always be across the split line.

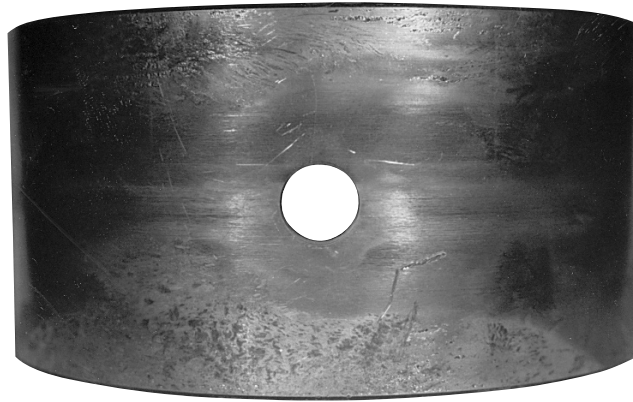
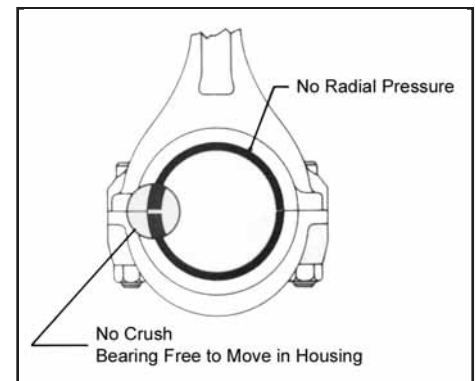
When a bearing with insufficient crush is assembled in an engine, it is loose and therefore free to work back and forth within its housing.

Because of the loss of radial pressure, there is inadequate contact with the bearing housing, thus impeding heat transfer away from the bearing. As a result, the bearing overheats causing deterioration of the bearing surface.

1. Clean mating surfaces of bearing caps and inspect for nicks and burrs prior to assembly.
2. Check journal surfaces for excessive wear and regrind if necessary.
3. Check the size and condition of the housing bore and recondition if necessary.
4. Correct shim thickness (if applicable).
5. Install new bearings using correct installation procedures (never file bearing parting faces).

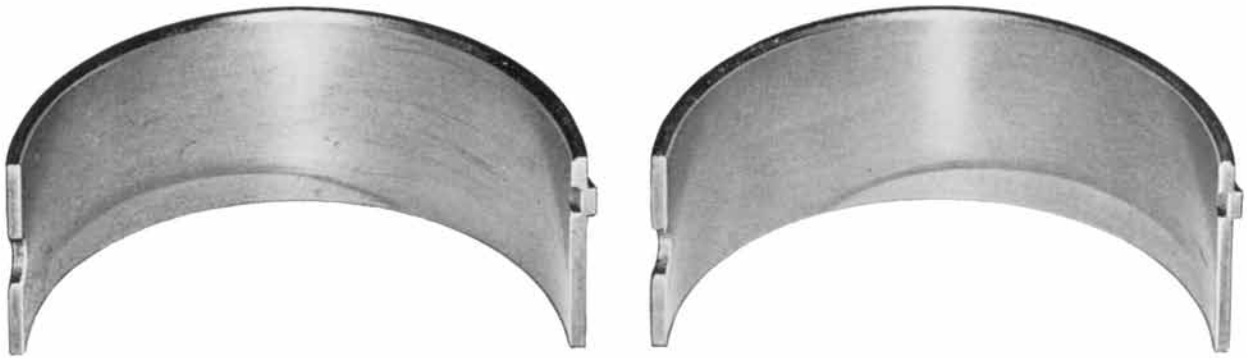
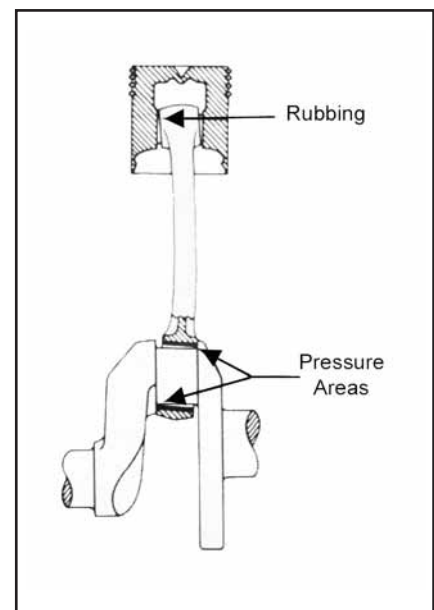
Excessive wear areas can be seen on opposite ends of the upper and lower connecting rod bearing shells. The wear is localized on one portion of the bearing surface with little or no wear on the remainder.

A bent or twisted connecting rod results in misalignment of the bore, causing the bearing to be cocked so the bearing edge makes metal-to-metal contact with the journal. These metal-to-metal contact areas cause excessive wear on the bearing surface.

1. Extreme operating conditions such as “hot rodding” and “lug-ging.”
2. Improper reconditioning. See inside front cover.
3. Dropping or abusing the connecting rod prior to assembly.

1. Inspect connecting rod and recondition or replace if bent or twisted.
2. Check journal surfaces for excessive wear and regrind if necessary.
3. Install bearing.
4. Avoid dropping or abusing the connecting rod prior to assembly.
5. Use proper installation techniques.
6. Check related upper cylinder parts and replace if necessary.

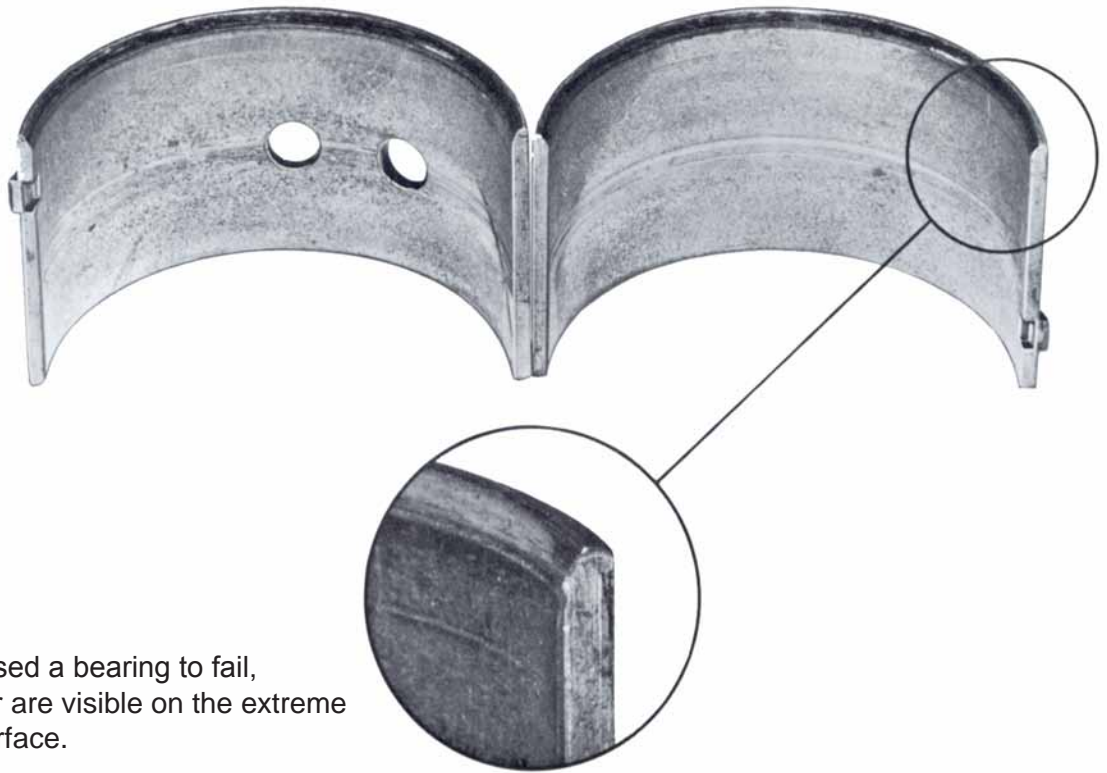
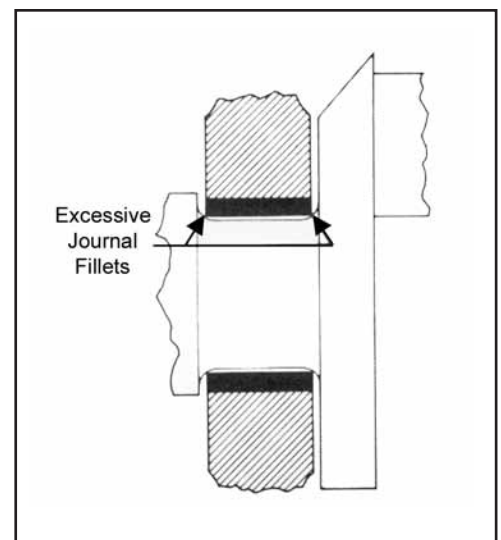
When fillet ride has caused a bearing to fail, areas of excessive wear are visible on the extreme edges of the bearing surface.

This metal-to-metal contact between the bearing and fillet causes excessive wear, leading to premature bearing fatigue.

1. Regrind the crankshaft paying particular attention to allowable fillet radii. **NOTE:** Be careful not to reduce fillet radius too much, since this can weaken the crankshaft at its most critical point.
2. Install new bearings with enlarged chamfers that allow proper fillet clearance.

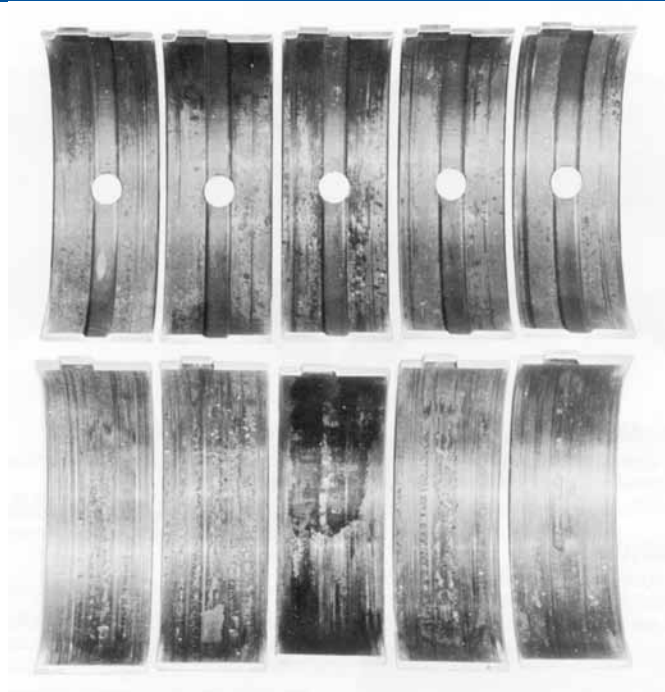
A wear pattern is visible on the upper or lower halves of the complete set of main bearings. The degree of wear varies from bearing to bearing depending upon the nature of the distortion. The center bearing usually shows the greatest wear.

A distorted crankcase imposes excessive loads on the bearings, with the point of greatest load being at the point of greatest distortion. These excessive bearing loads cause excessive bearing wear. Also, oil clearance is reduced and metal-to-metal contact is possible at the point of greatest distortion.

Alternating periods of engine heating and cooling during operation is a prime cause of crankcase distortion. As the engine heats the crankcase expands, and as it cools, the crankcase contracts. This repetitive expanding and contracting causes the crankcase to distort over time in some situations.

1. Determine if distortion exists by use of Prussian blue or visual methods.
2. Align bore the housing (if applicable).
3. Install new bearings.

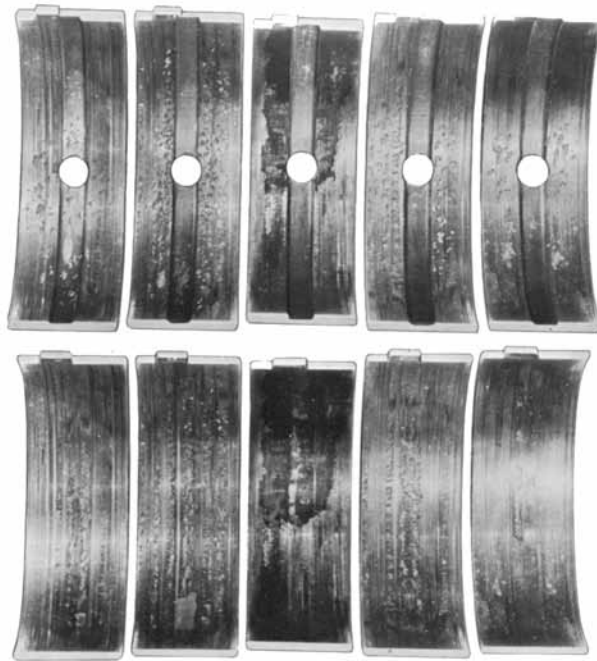
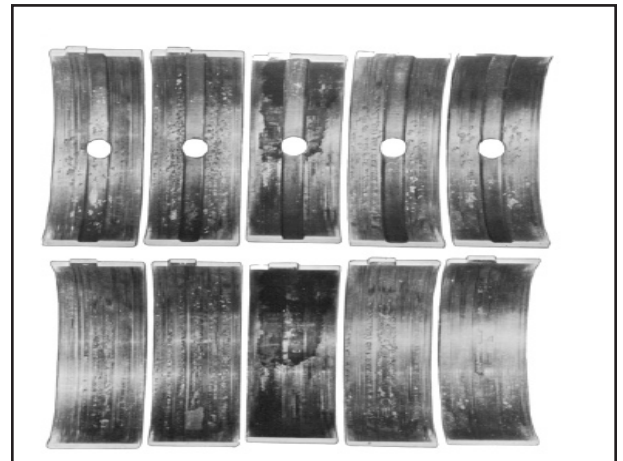
A wear pattern is visible on the upper and lower halves of the complete set of main bearings. The degree of wear varies from bearing to bearing depending upon the nature of the distortion. The center bearing usually shows the greatest wear.

A distorted crankshaft subjects the main bearings to excessive loads, with the greatest load being at the point of greatest distortion. The result is excessive bearing wear. Also, the oil clearance spaces between journals and bearings are reduced, making it possible for metal-to-metal contact to occur at the point of greatest distortion.

A crankshaft is usually distorted due to extreme operating conditions, such as “over-speeding” and “lugging”. It may also be caused by improper handling prior to installation.

1. Determine if distortion exists by means of prussian blue or visual methods.
2. Install a new or reconditioned crankshaft.
3. Install new bearings.

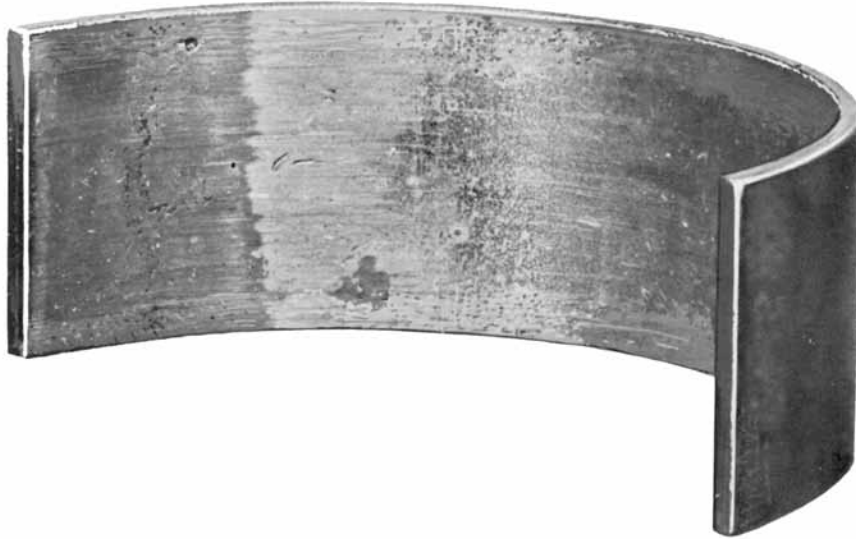
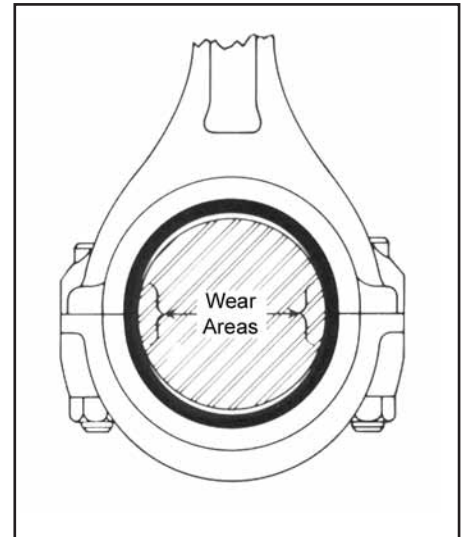
Localized excessive wear areas are visible near the parting line on both top and bottom shells.

Oil clearance near the parting line is decreased to such an extent that metal-to-metal contact between bearing and journal takes place, resulting in areas of above-normal wear.

Alternating loading and flexing of the connecting rod can cause the bearing housing to become elongated. And because replacement bearing shells, when installed, tend to conform to the shape of the bearing housing, this can result in an out-of-round bearing surface.

1. Check the roundness of bearing housings before installing the new bearings. If they are found to be out-of-round, recondition the bearing housings (or replace connecting rod).
2. Check the journal surfaces for excessive wear and regrind if necessary.
3. Install new bearings.

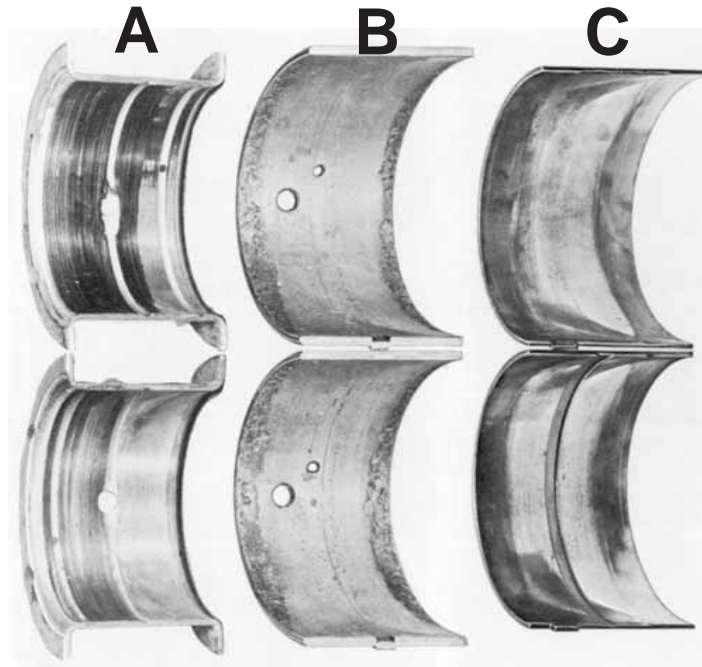
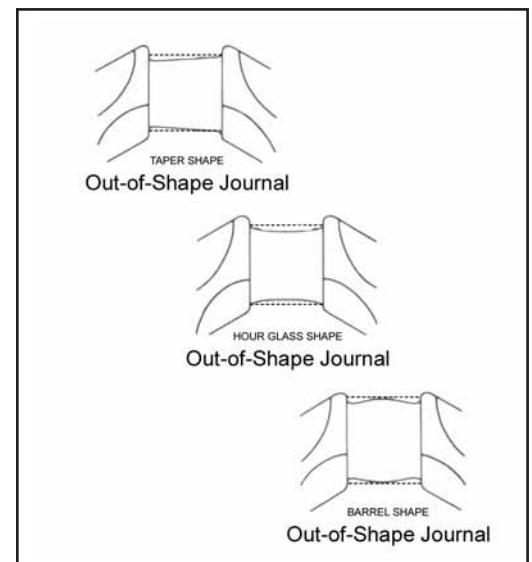
In general, if a bearing has failed because of an out-of-shape journal, an uneven wear pattern is visible on the bearing surface. Specifically, however, these wear areas can be in any one of three patterns: Photo A above shows the wear pattern caused by a **tapered** journal. Photo B shows the wear pattern caused by an **hour-glass** shaped journal. Photo C shows the pattern of a **barrel** shaped journal.

An out-of-shape journal imposes an uneven distribution of the load on the bearing surface, increasing heat generated and thus accelerating bearing wear. An out-of-shape journal also affects the bearing's oil clearance, making it insufficient in some areas and excessive in others, thereby upsetting the proper functioning of the lubrication system.

If the journal is **hour-glass** or **barrel** shaped, this is usually the result of improper machining or polishing.

Regrinding the crankshaft can best remedy out-of-shape journal problems. Then install new bearings in accordance with proper installation procedures.

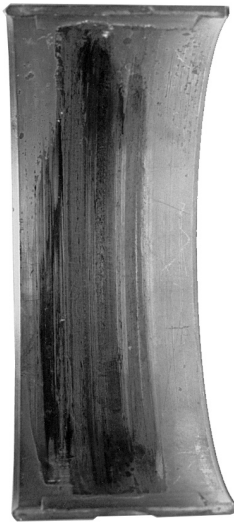
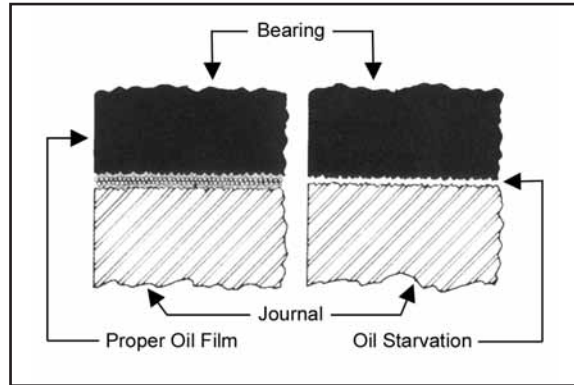
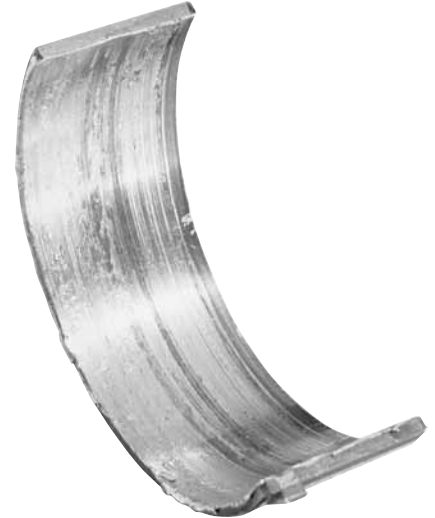
When a bearing has failed due to oil starvation, its surface is usually very shiny. In addition, there may be excessive wear of the bearing surface due to the wiping action of the journal. In the most severe cases the bearing surface will be smeared or scratched and torn. The bearing will begin to turn dark blue to black in color.

The absence of a sufficient oil film between the bearing and the journal permits metal-to-metal contact. The resulting wiping action causes premature bearing fatigue.

1. Insufficient oil clearance – usually the result of utilizing a replacement bearing that has too great a wall thickness. In some cases, the journal may be oversize.
2. Broken or plugged oil passages, prohibiting proper oil flow.
3. A blocked oil suction screen or oil filter.
4. A malfunctioning oil pump or pressure relief valve.
5. Misassembling main bearings metering off an oil hole.
6. Lubrication system not primed before start up.

1. Double-check all measurements taken during the bearing selection procedure to catch any errors in calculation. (During assembly check oil clearance with Plastigage®.)
2. Check to be sure that the replacement bearing you are about to install is the correct one for the application.
3. Check the journals for damage and regrind if necessary.
4. Check engine for possible blockage of oil passages, oil suction screen and oil filter.
5. Check the operation of the oil pump and pressure relief valve.
6. Be sure that the oil holes are properly indexed when installing the replacement bearings.
7. Advise the operator about the results of engine lugging.
8. Always prime the lubrication system before the engine is started the first time.

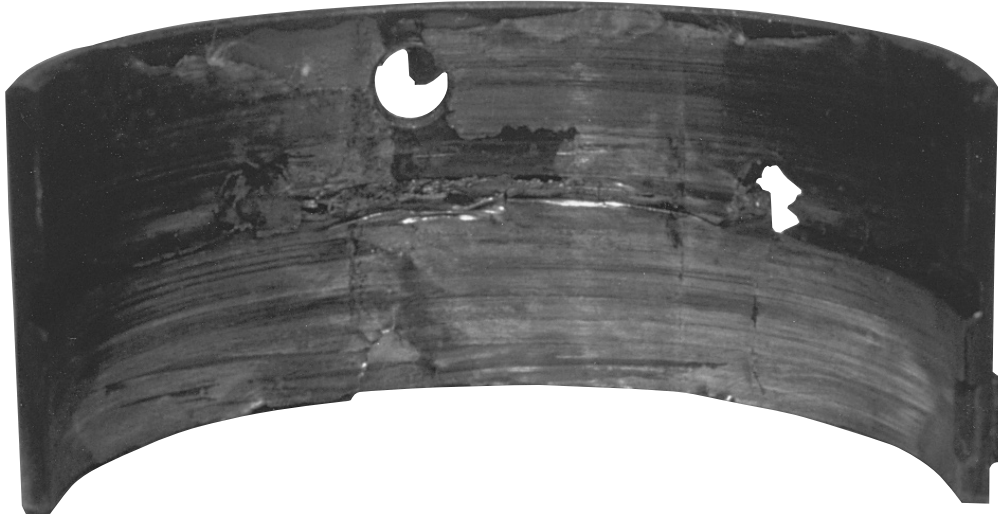
A hot short is a catastrophic failure that results from one of the conditions already covered in detail. To properly correct this it must first be determined which specific condition lead to the hot short. For further details please see:

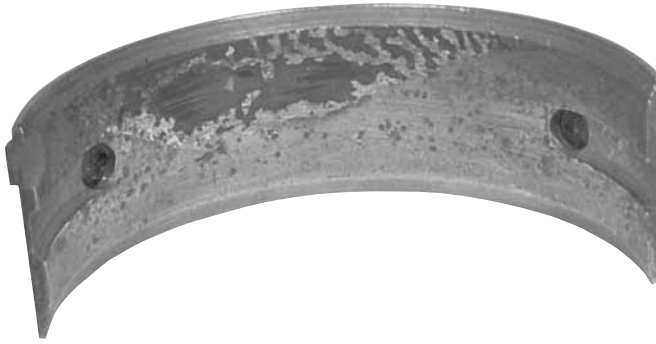
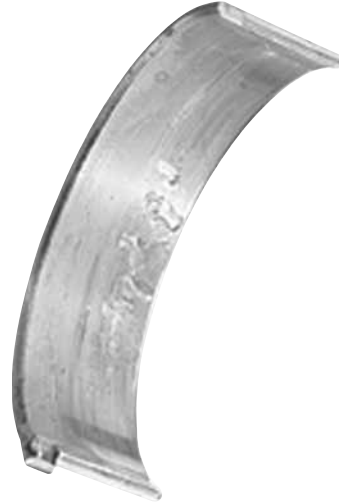
Bearing surface cracked, small irregular areas of surface material missing from the bearing lining.

Heavy pulsating loads imposed upon the bearing by reciprocating motion within the engine cause the bearing surface to crack due to metal fatigue.

Fatigue cracks widen and deepen perpendicular to the bond line. Close to the bond line, fatigue cracks turn and run parallel to the bond line, eventually joining and causing pieces of the surface to flake out.

1. Overloading (lugging, detonation, or overfueling).
2. Uneven loading (see sections on misalignment).
3. Bearing material of inadequate fatigue strength for application.
4. Bearing failure due to surface fatigue can be the result of the normal life span of the bearing being exceeded.

1. If the service life for the old bearing was adequate, replace with the same type of bearing to obtain a similar service life.
2. If the service life of the old bearing was too short, replace with a heavier duty bearing to obtain a longer life.
3. Replace all other bearings (main connecting rod and camshaft) as their remaining service life may be short.
4. Recommend that the operator avoid "hot rodding" and "lugging" as these tend to shorten bearing life.
5. Check for misassembly. Use proper installation techniques.

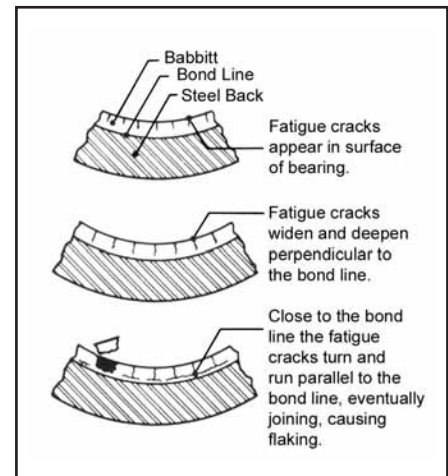
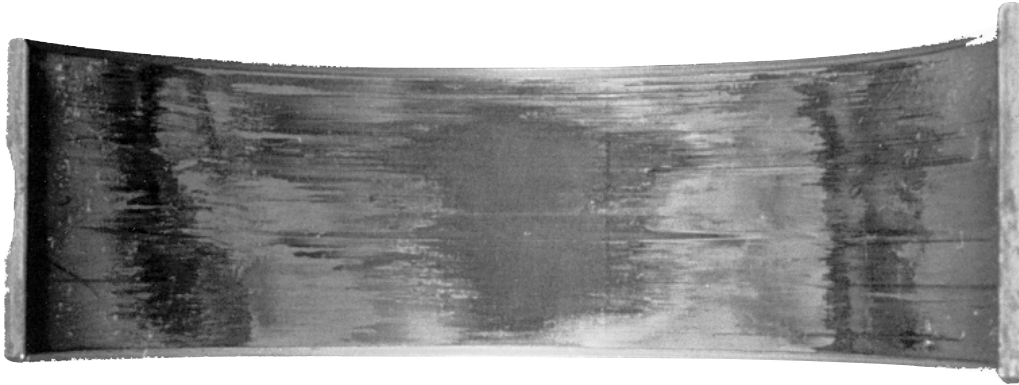
This is usually the result of contamination of the oil from either the fuel system or internal engine leaks. This condition is further pronounced when there is poor routine maintenance.

1. Identify and correct source of contamination.
2. Install new bearings using correct installation procedures.
3. Use a better quality fuel, if possible.
4. Oil should be changed at recommended intervals using the proper grade and rating. In some applications oil analysis may be needed to determine the optimum oil change intervals.

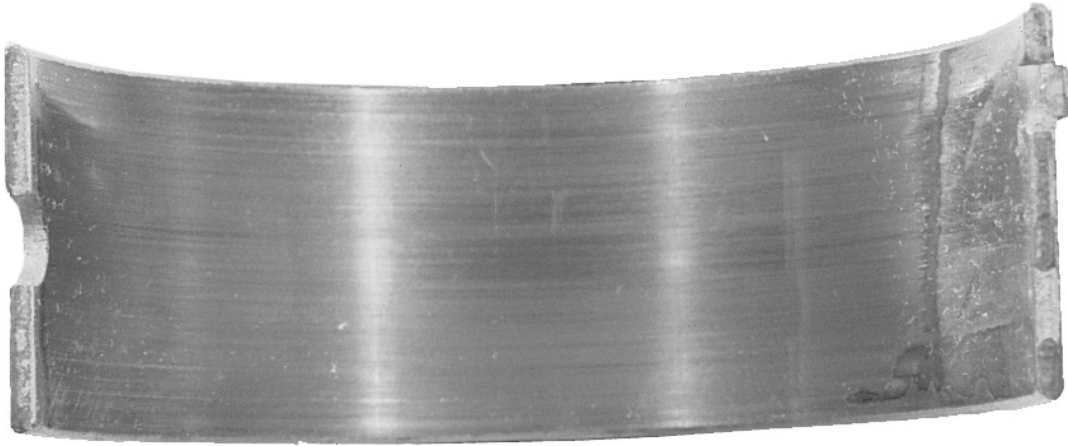
Wall thickness reduced from original dimension. Bearing surface worn and polished but not smeared, torn or scored. No evidence of heat, no embedded foreign particles.

Grinding and polishing the crankshaft journals produce burrs that are so small that we can't see or feel them. Not only is it important that the surface finish meet recommended average Ra or better, but it is also important to always grind opposite to rotation and polish in the direction of rotation. Otherwise it is possible for these microscopic burrs to disrupt the oil film and abrade away the bearing surface.
