Engine Bearing

failure analysis guide

*A guide to analysis and correction of
premature engine bearing failures*

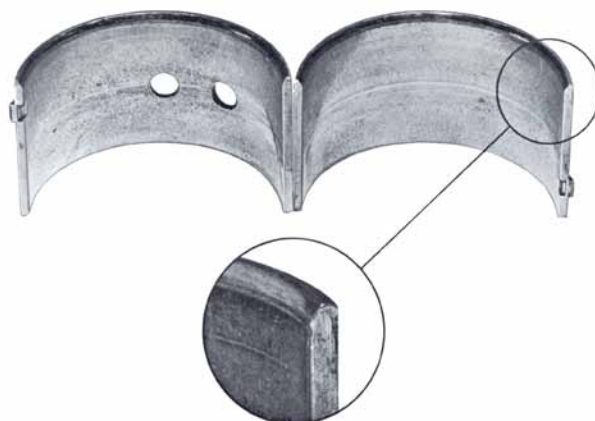
FILLET RIDE..... PAGE 10

When fillet ride has caused a bearing to fail, areas of excessive wear are visible on the extreme edges of the bearing surface.

This metal-to-metal contact between the bearing and fillet causes excessive wear, leading to premature bearing fatigue.

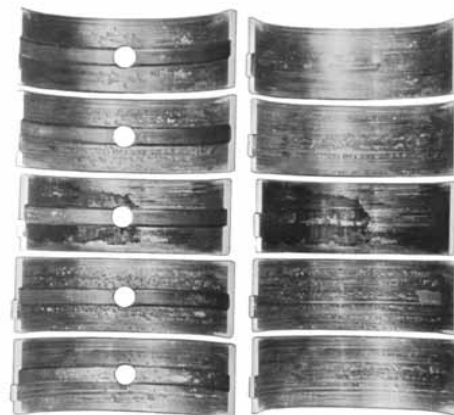
DISTORTED CRANKCASE..... PAGE 11

A wear pattern is visible on the upper or lower halves of the complete set of main bearings. The degree of wear varies from bearing to bearing depending upon the nature of the distortion. The center bearing usually shows the greatest wear.

A distorted crankcase imposes excessive loads on the bearings, with the point of greatest load being at the point of greatest distortion. These excessive bearing loads cause excessive bearing wear. Also, oil clearance is reduced and metal-to-metal contact is possible at the point of greatest distortion.

Alternating periods of engine heating and cooling during operation is a prime cause of crankcase distortion. As the engine heats the crankcase expands, and as it cools, the crankcase contracts. This repetitive expanding and contracting causes the crankcase to distort over time in some situations.

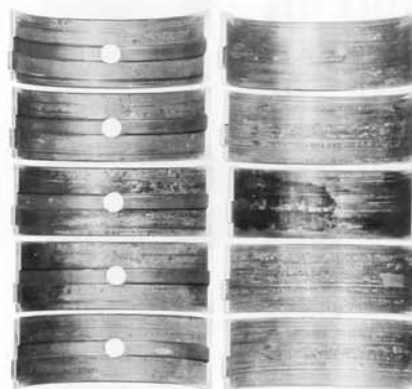
BENT CRANKSHAFT PAGE 12

A wear pattern is visible on the upper and lower halves of the complete set of main bearings. The degree of wear varies from bearing to bearing depending upon the nature of the distortion. The center bearing usually shows the greatest wear.

A distorted crankshaft subjects the main bearings to excessive loads, with the greatest load being at the point of greatest distortion. The result is excessive bearing wear. Also, the oil clearance spaces between journals and bearings are reduced, making it possible for metal-to-metal contact to occur at the point of greatest distortion.

A crankshaft is usually distorted due to extreme operating conditions, such as “over-speeding” and “lugging”. It may also be caused by improper handling prior to installation.

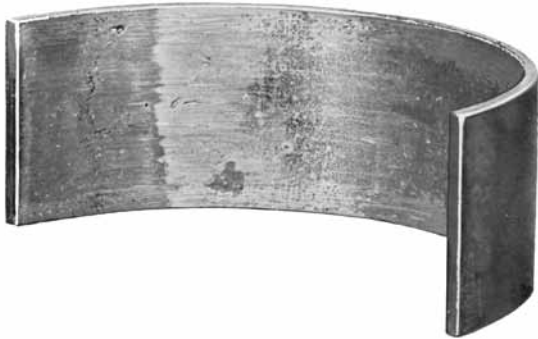
OUT-OF-ROUND BORE PAGE 13

Localized excessive wear areas are visible near the parting line on both top and bottom shells.

Oil clearance near the parting line is decreased to such an extent that metal-to-metal contact between bearing and journal takes place, resulting in areas of above-normal wear.

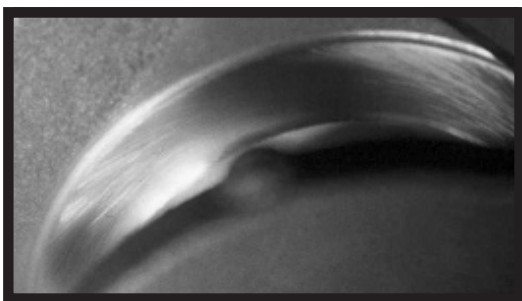
AVOID - SWIRL PATTERN

Obtaining a good finish on the thrust face of a crankshaft is difficult to do because it uses side-wheel grinding. Side grinding causes marks that spiral outward toward the OD of the thrust face and may also cause cross-hatch marks resembling honing patterns. Both patterns are detrimental to the formation of an oil film because they work like wipers as the shaft rotates. **Grinding marks must be removed by polishing. Only a circular pattern should remain. Surface finish should be checked in a tangential direction and must be held to 10 Ra max. The thrust surface should be flat within .0002” max.**
